Navajo Abandoned Uranium Mine Site Screen Report

Church Rock ISL Site

Navajo AUM Eastern Region

May 2009

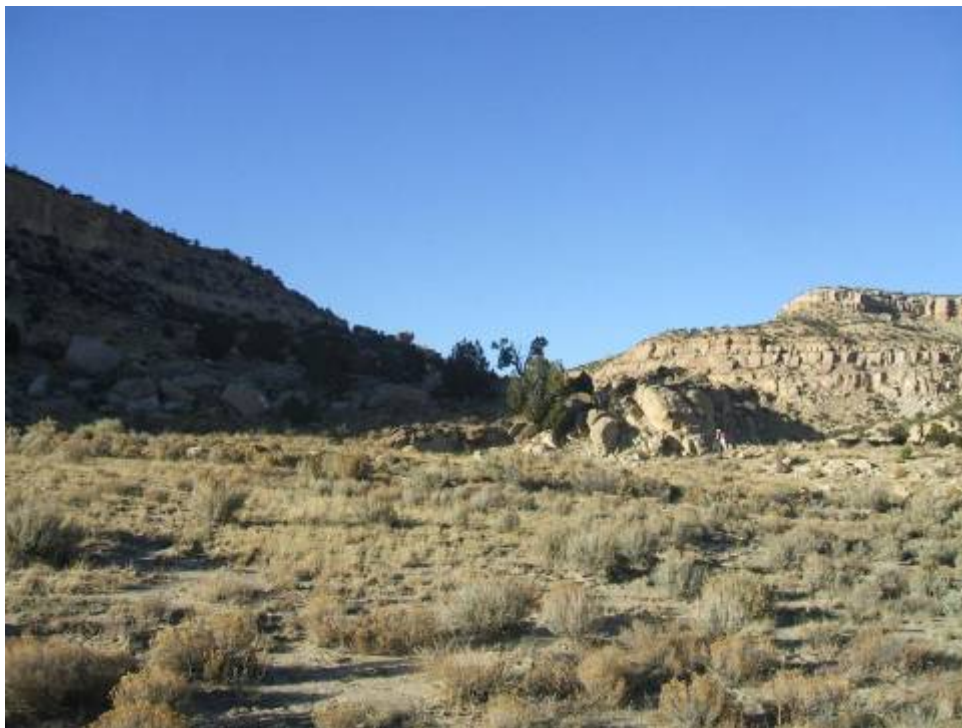
Photo 2. Church Rock ISL mine site, towards the north

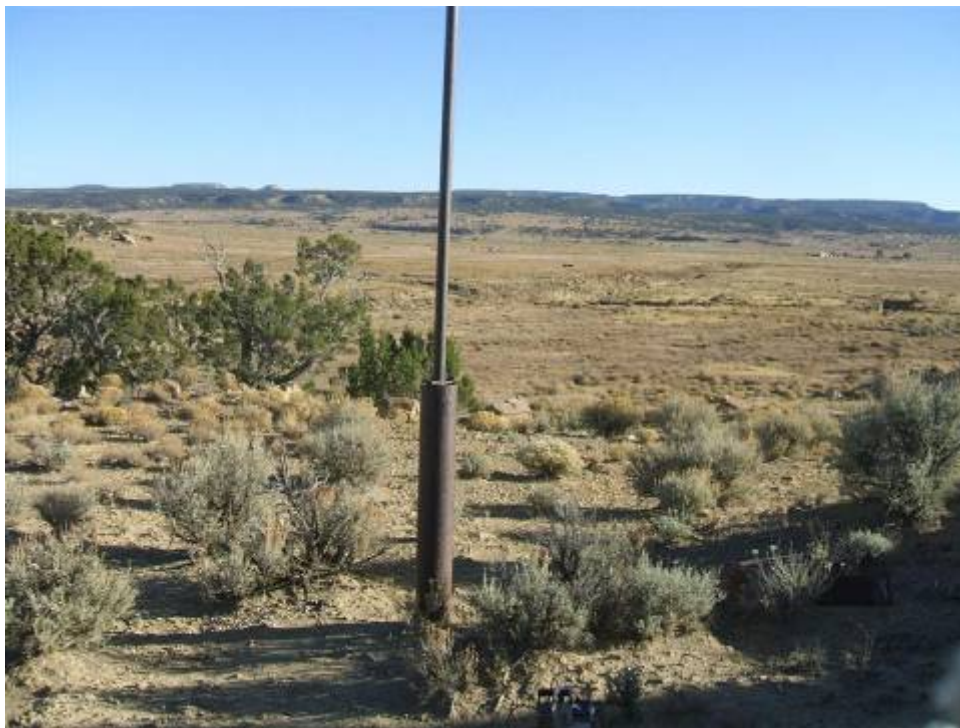
Photo 3. Metal pipe and well within the southern portion of the mine site, towards the southeast

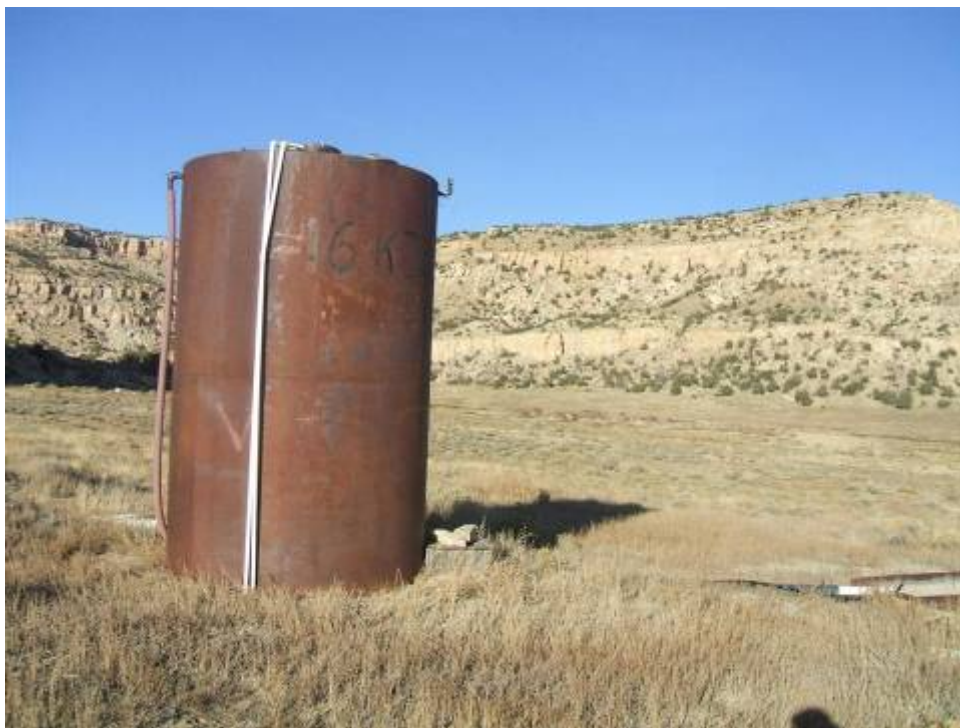
Photo 4. Water tank and feeding trough south of the mine site, towards the north

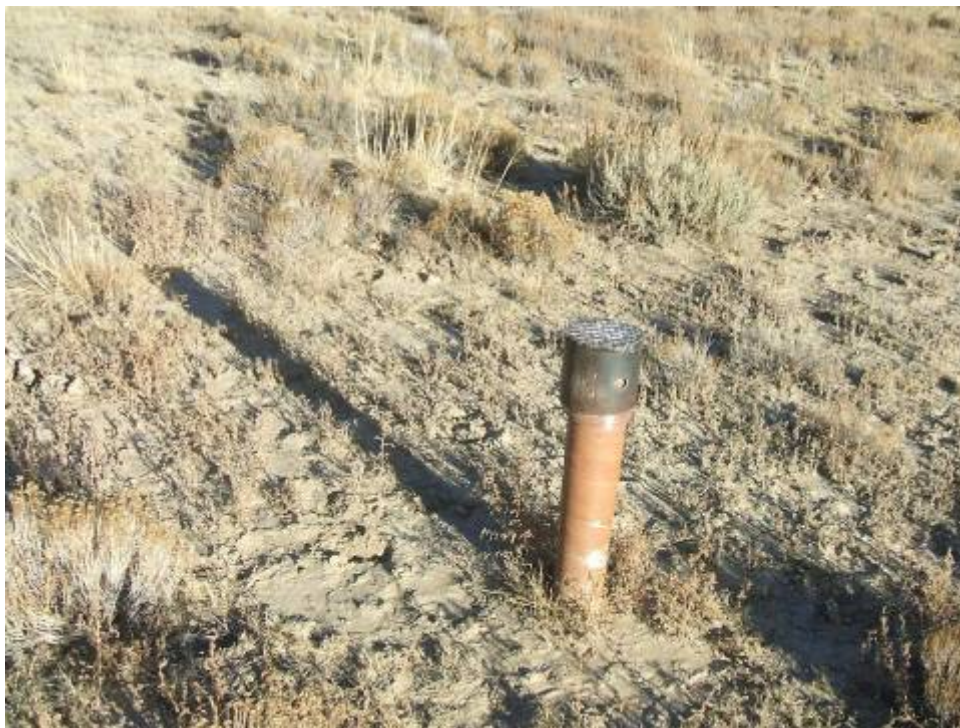
Photo 5. ISL monitoring well surrounding the mine site, towards the east

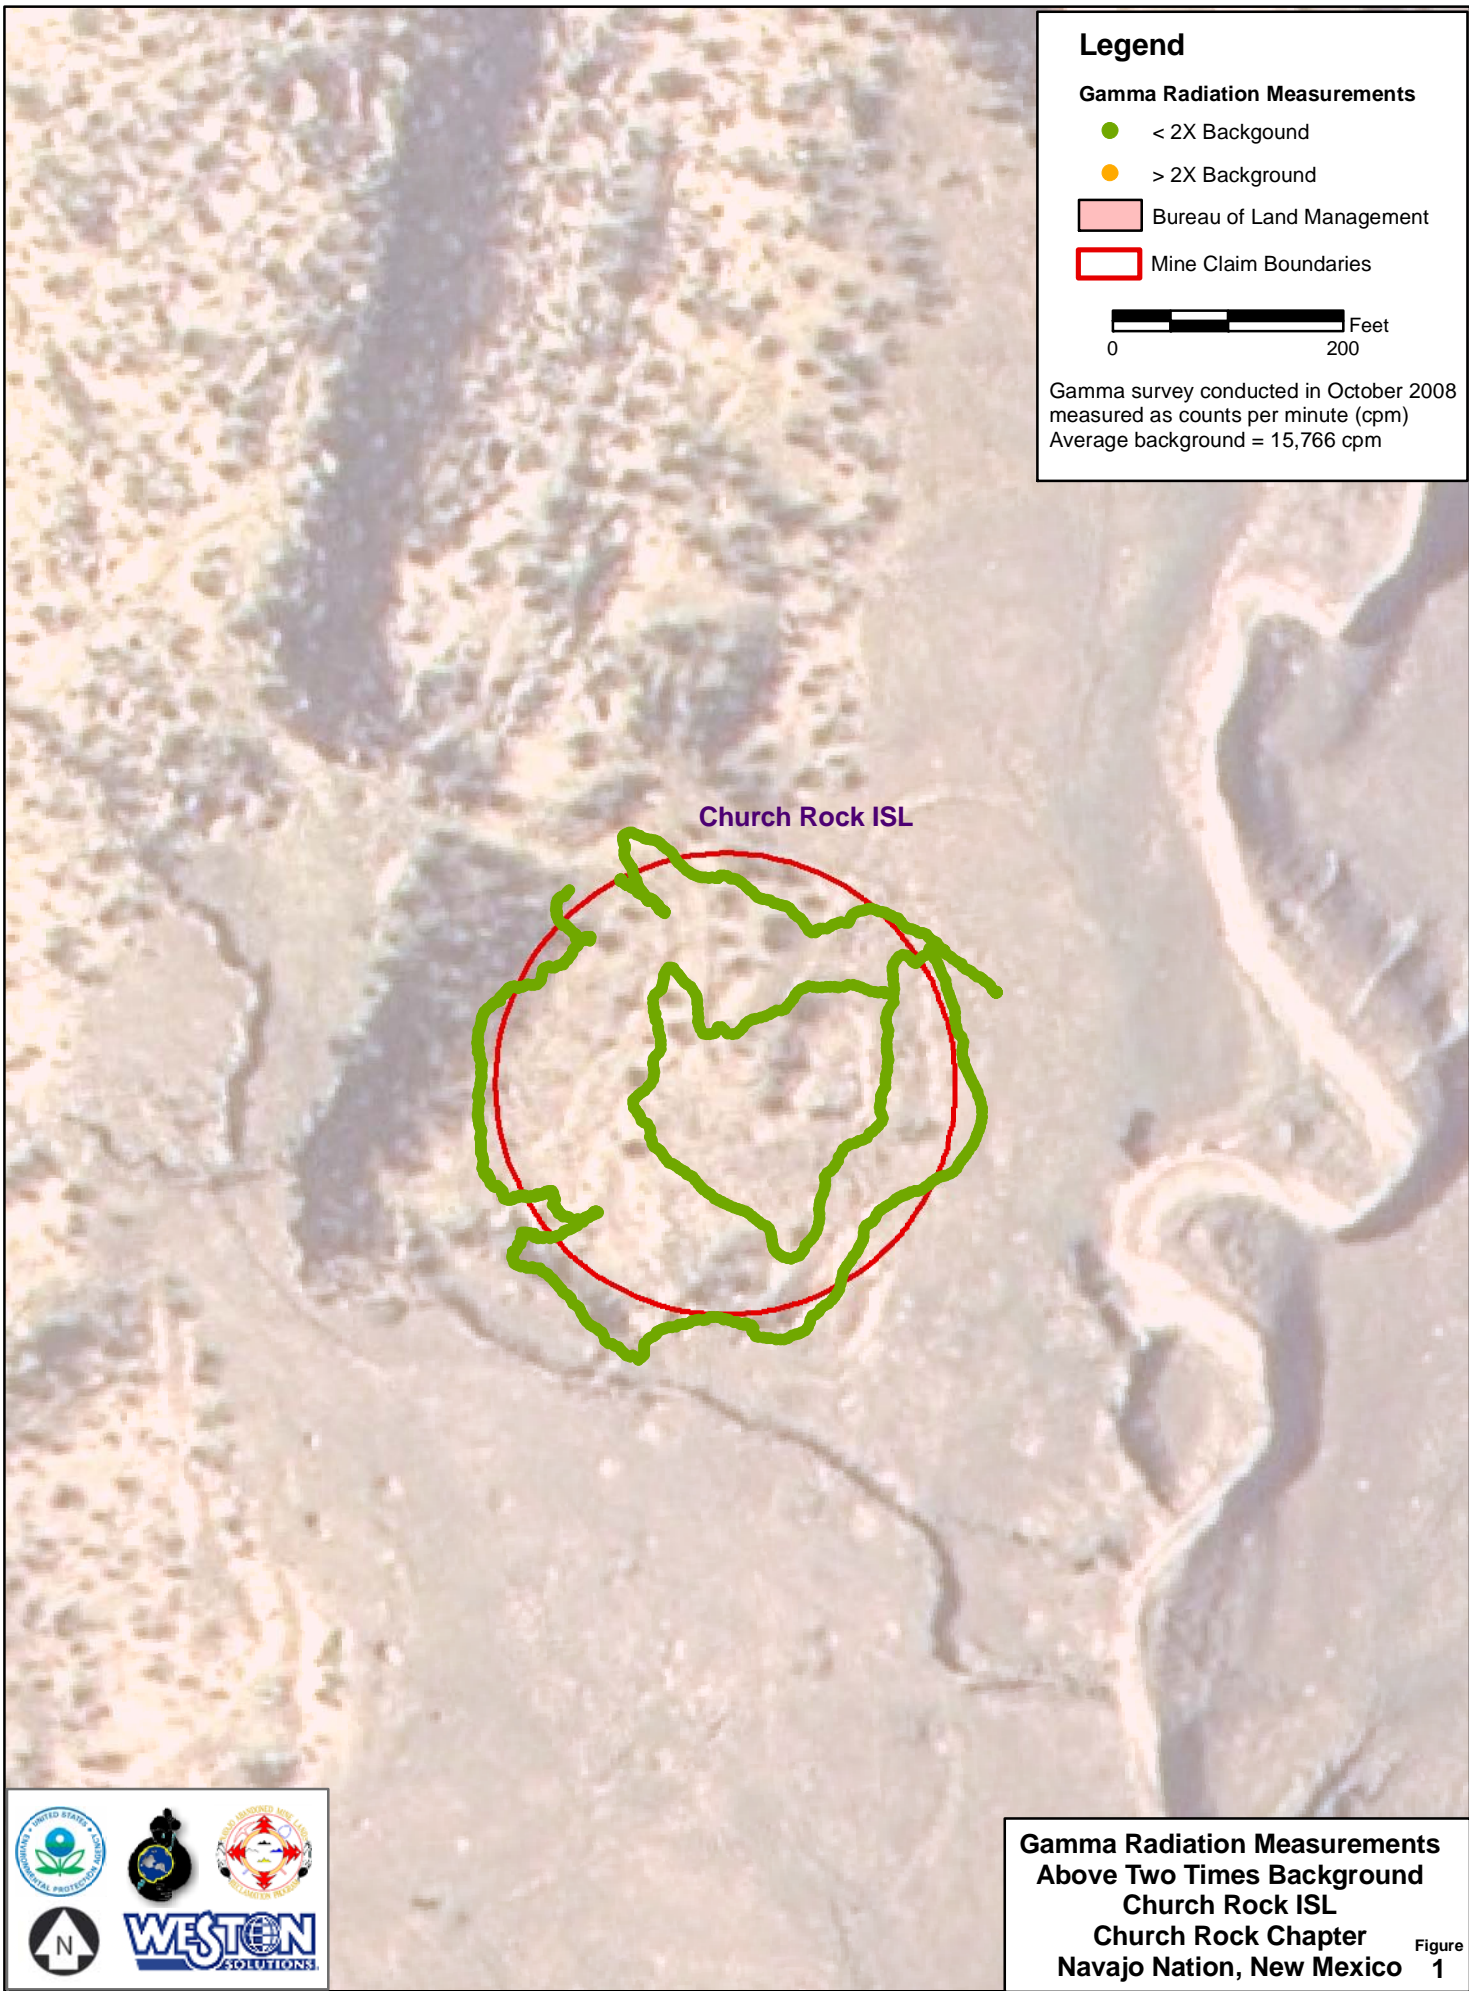
Figure 1

A total of 1,155 gamma radiation measurements were collected from mine sites, ranging from 9,946 cpm to 16,121 cpm. The measurements are represented in Figures 1 and 2.

Gamma survey conducted in October 2008
measured as counts per minute (cpm)
Average background = 15,766 cpm
